**ENVIRONMENTAL ASSESSMENT OF THE
PROPOSED CAPITAL REGION RESOURCE
RECOVERY CENTRE**

Technical Support Document # 1

**COMPARATIVE EVALUATION OF
ALTERNATIVE SITES
CAPITAL REGION RESOURCE RECOVERY
CENTRE**

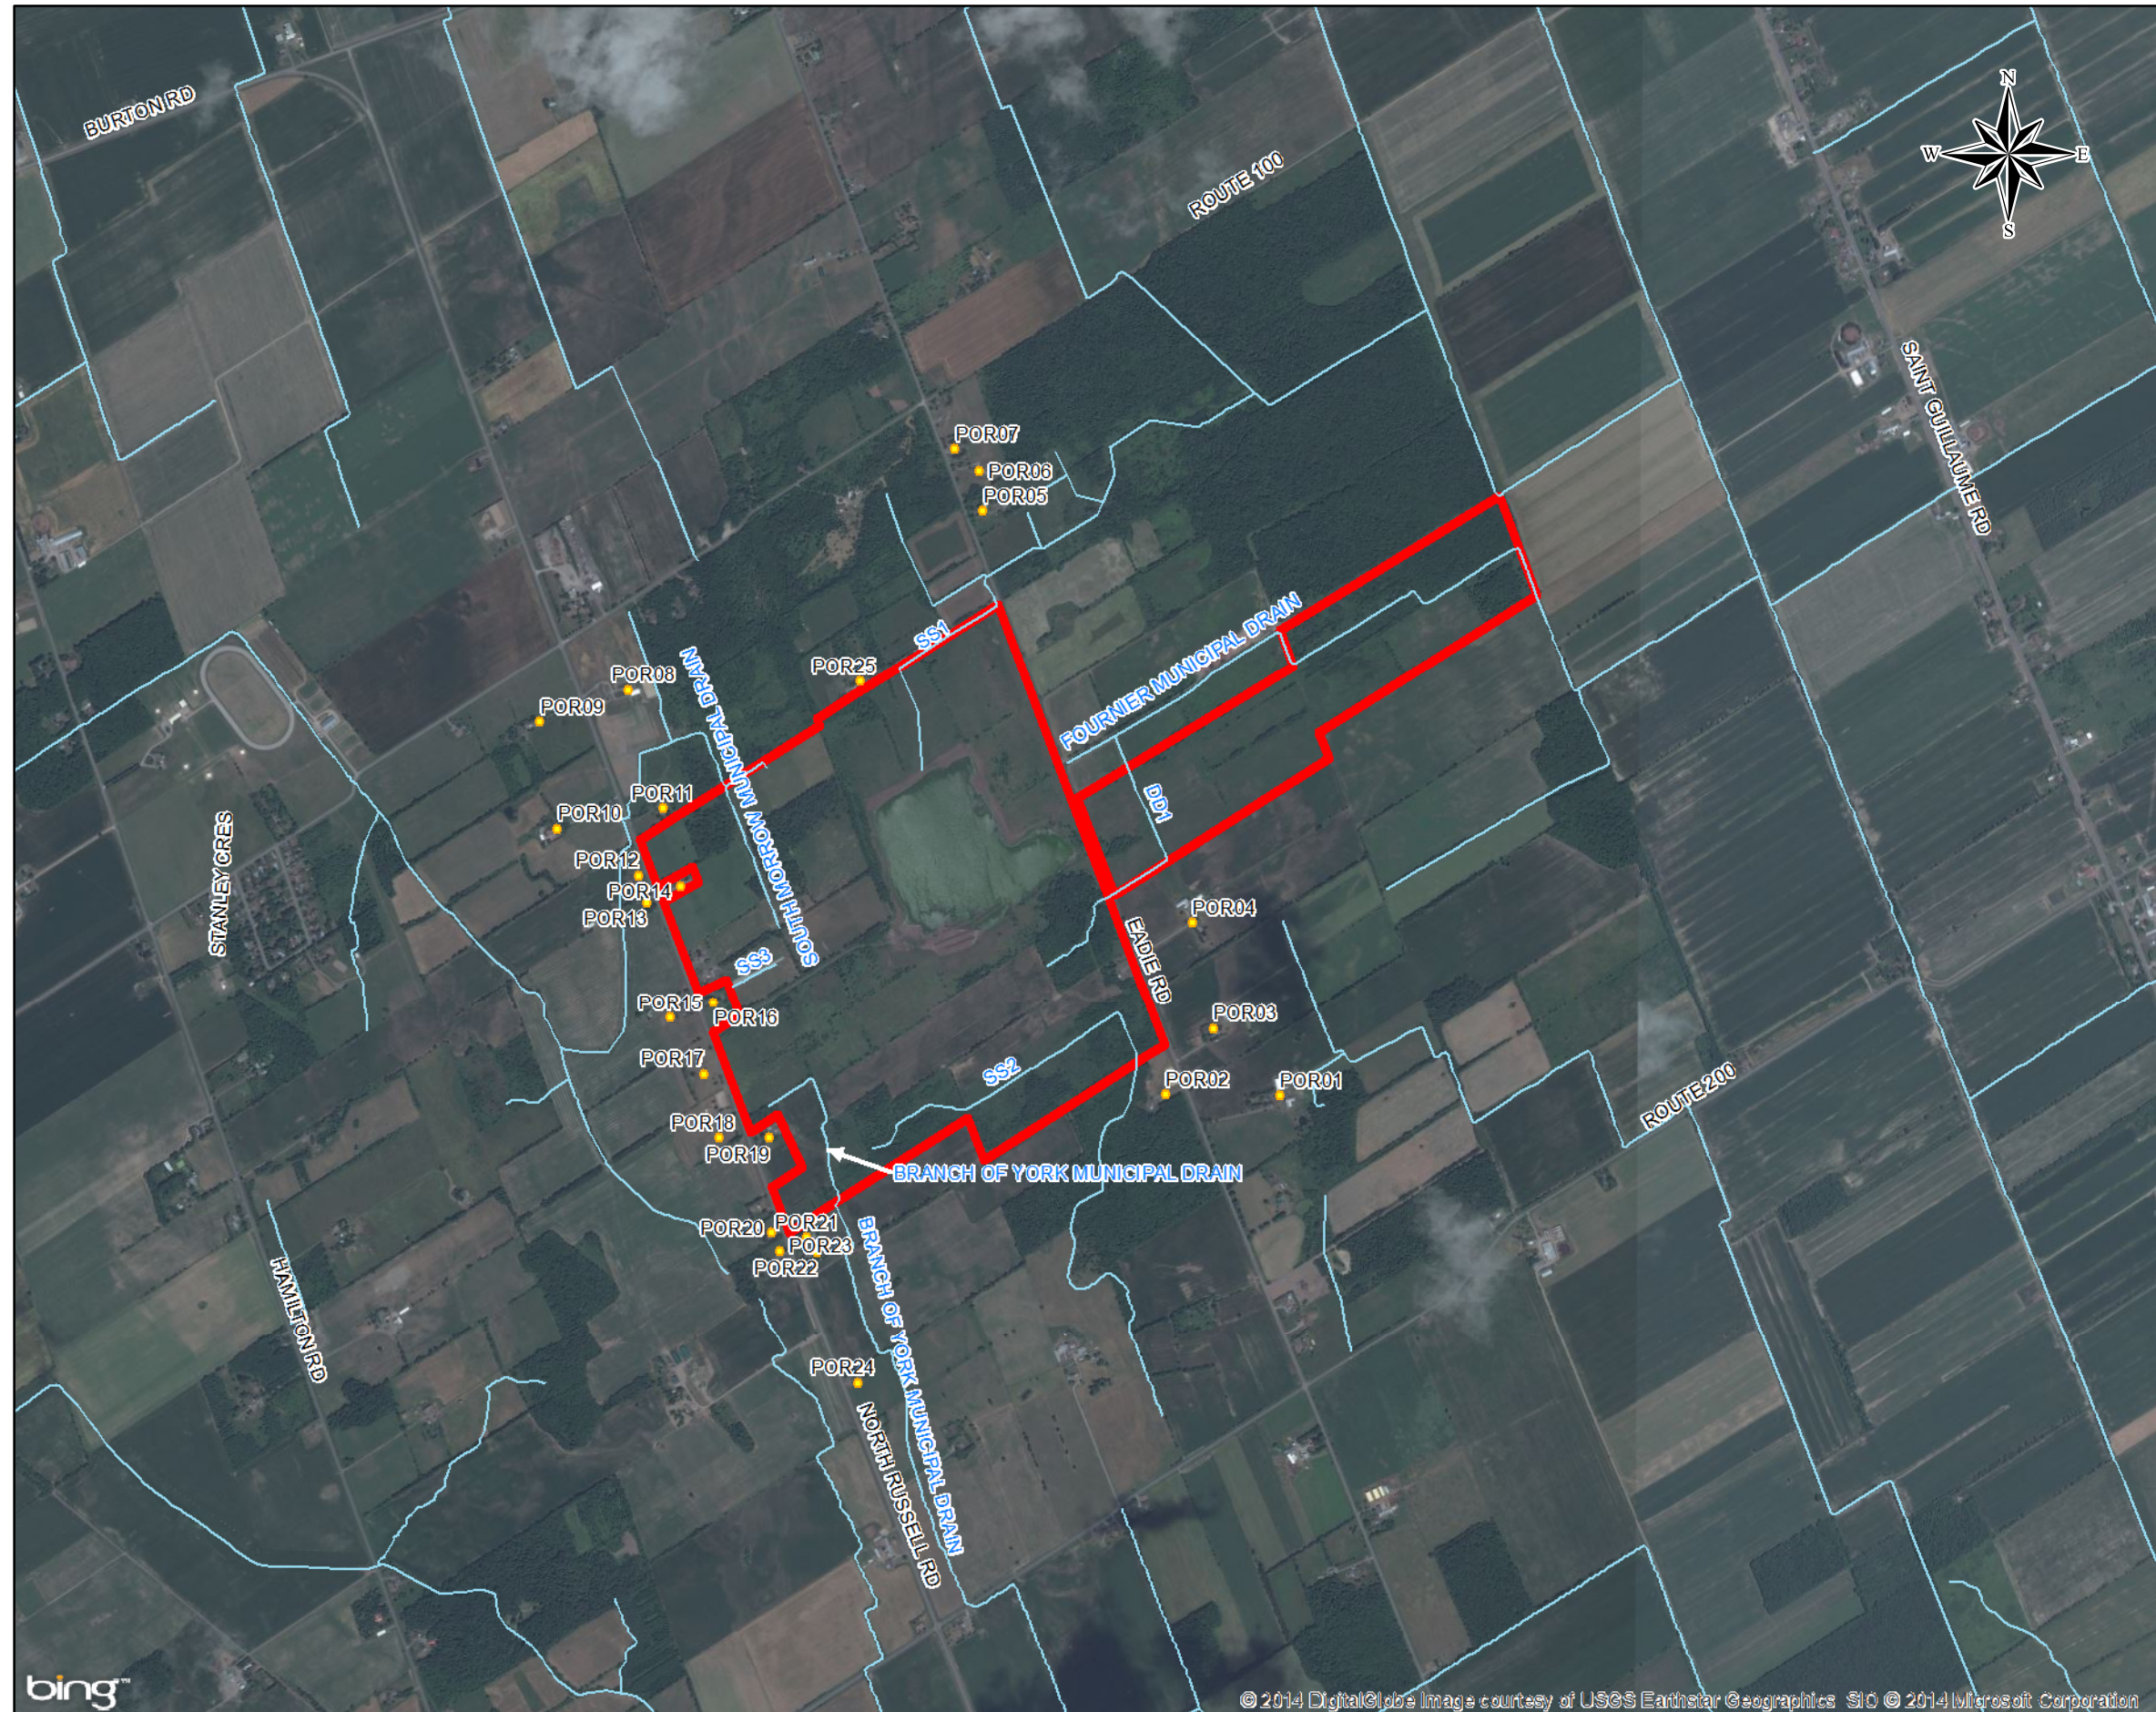
Based on the Site reconnaissance, 25 sensitive receptors have been identified within the Site-vicinity as shown on Figure 2.2-1. Of these, 13 are located adjacent to the property line, mostly on the west side of the Site. Two PORs were identified on the NRR Site property; however it is understood that these would be removed when the Undertaking is established, therefore they were not considered in the analysis.

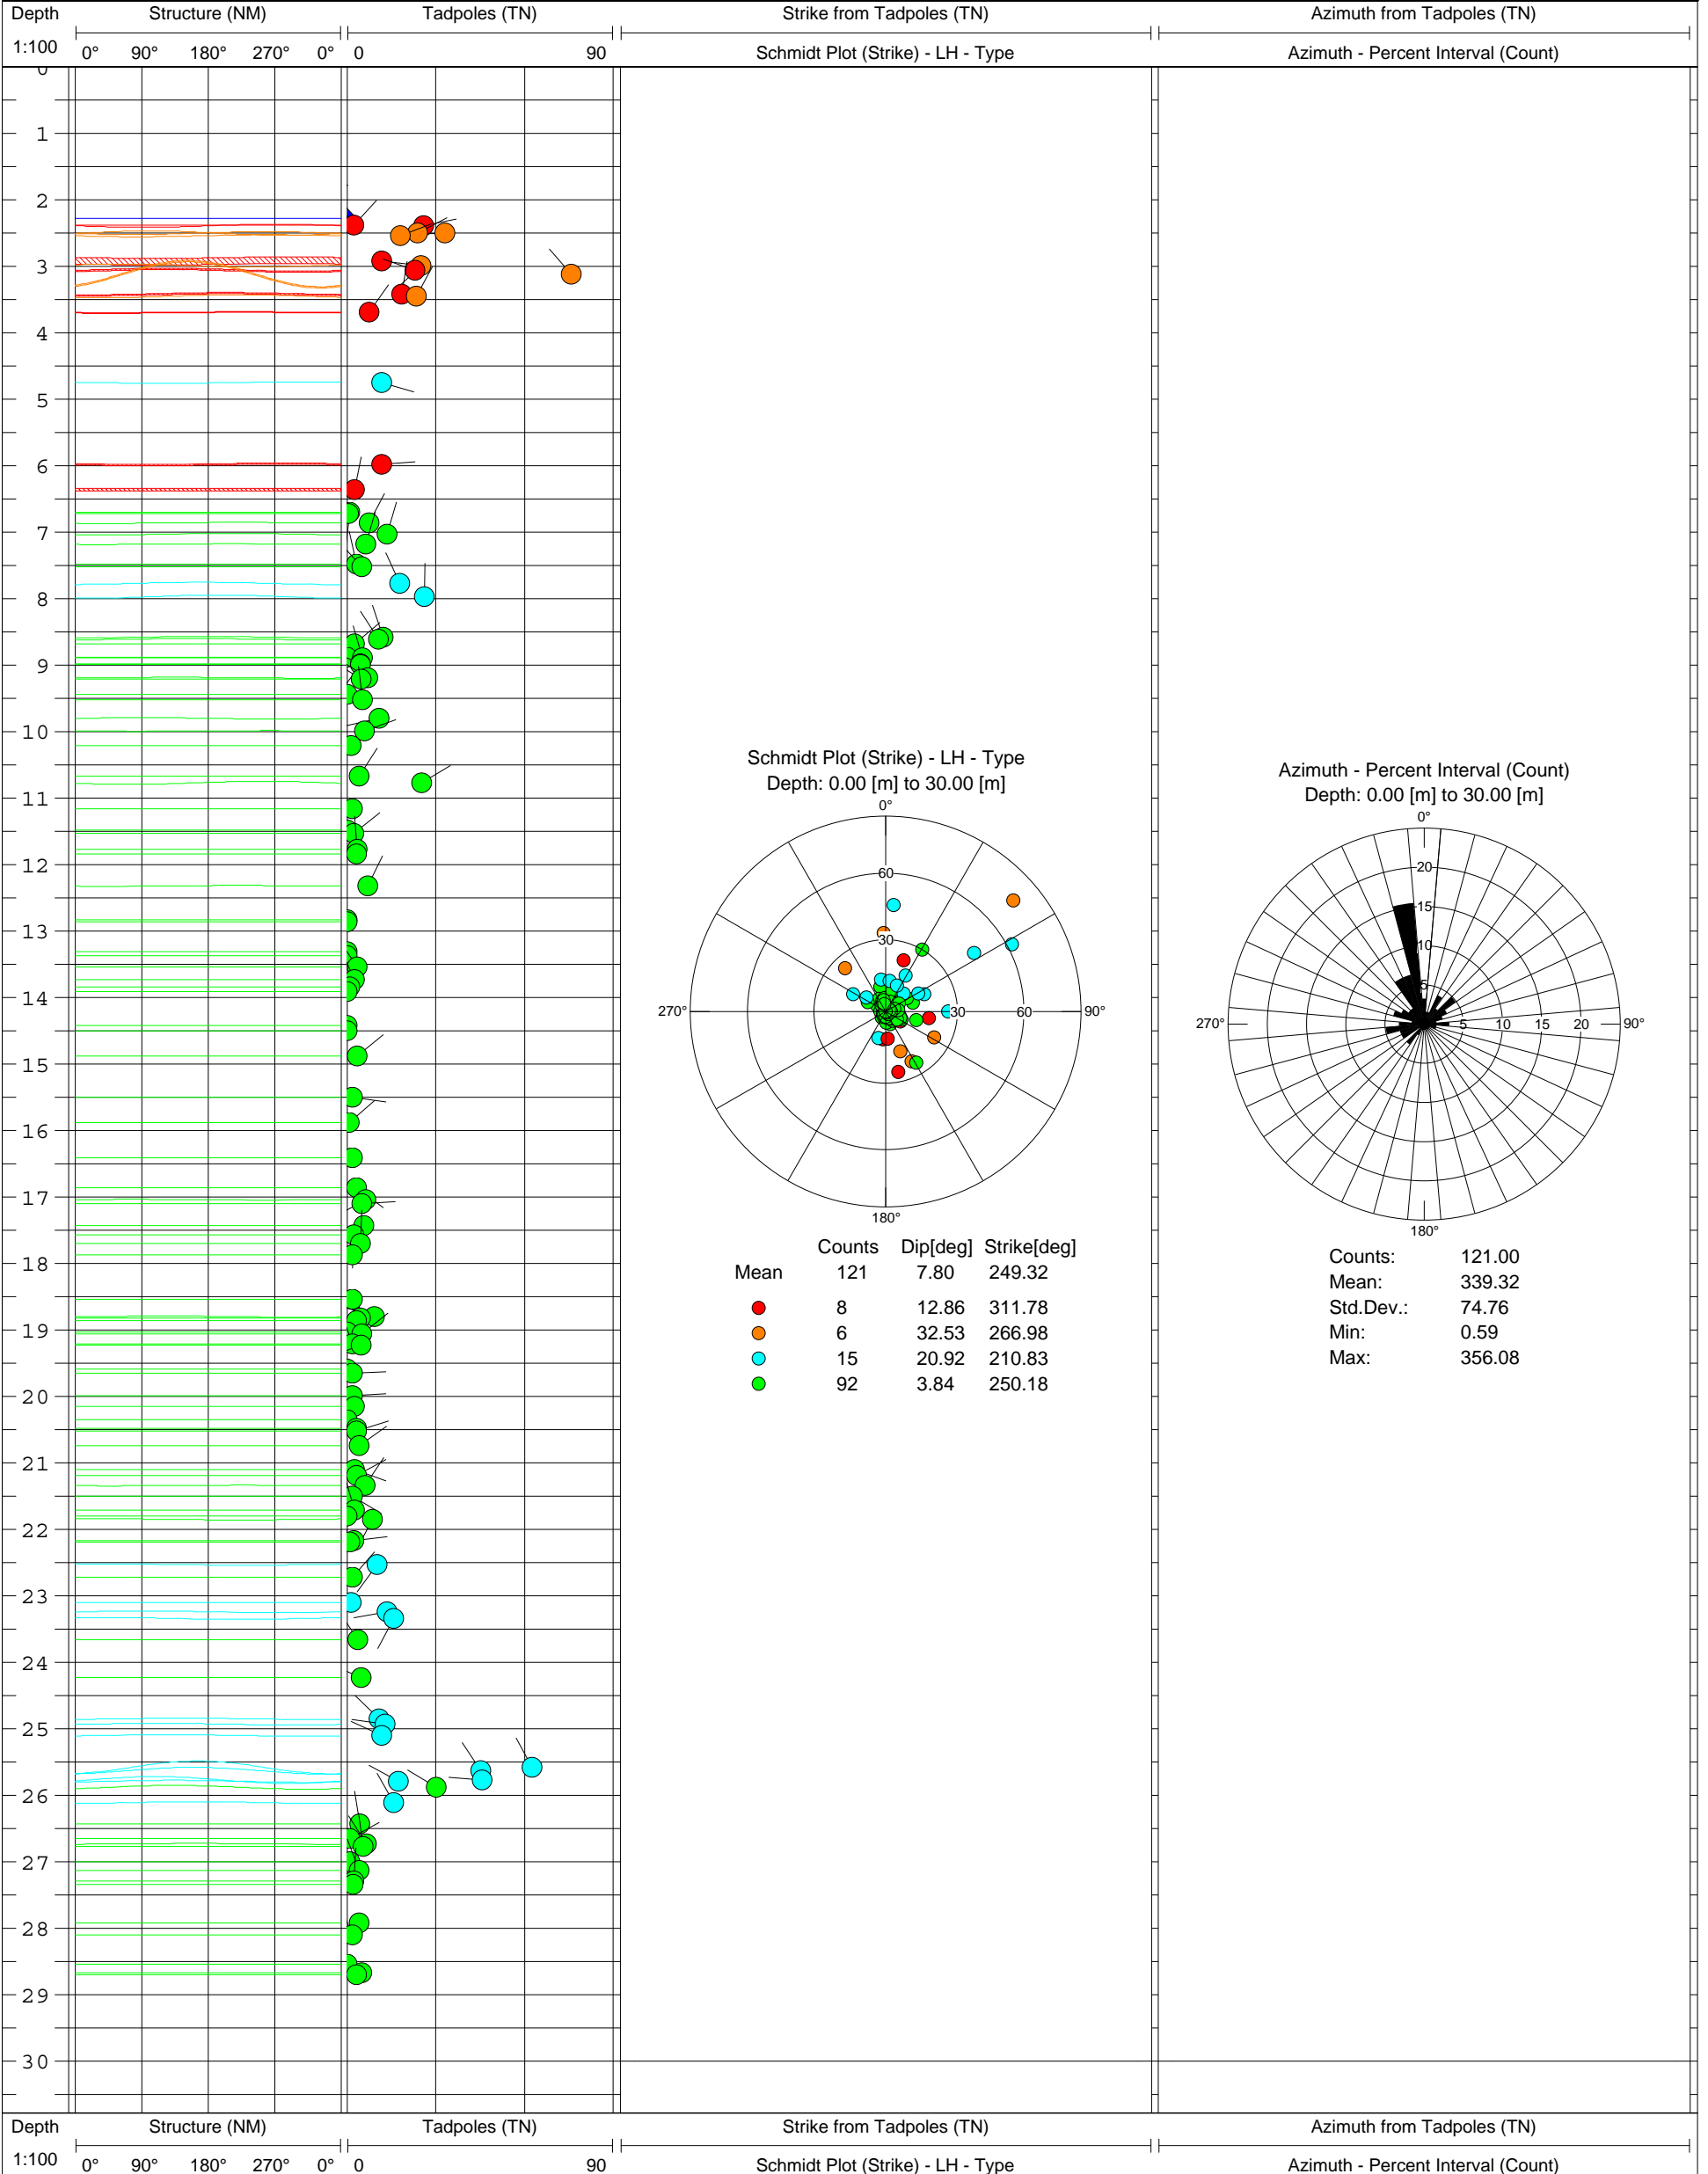
GEOPHYSICAL RECORD OF BOREHOLE: BH09-4

The general result for boreholes BH09-4, BH09-7 and BH09-8 is that the majority of flow encountered is shallow, from within the shallow fractured bedrock zones, and that permeability is lower with depth.

The fluid temperature/resistivity and heat pulse flow meter logs were collected under non-pumping and pumping conditions. Both sets of data are shown on the logs in Attachments TSD#1-B-4-2, TSD#1-B-4-3 and TSD#1-B-4-4. The data are also shown in tables contained within the appendices.

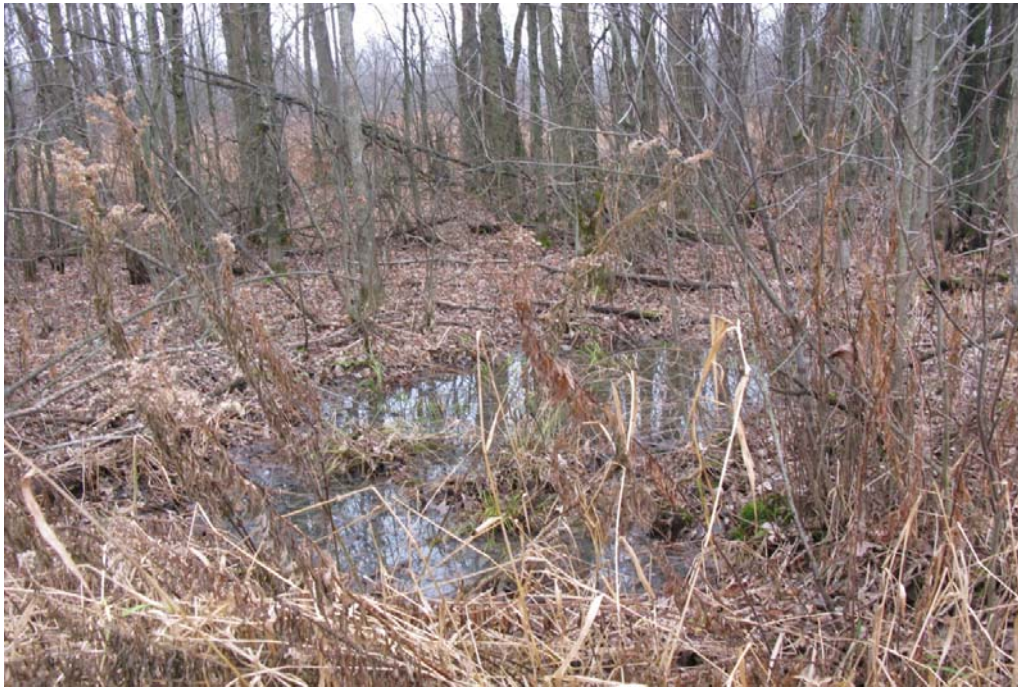
Image 5: Wet area and woodlot southeast of quarry, facing east.

The study area is located within the Upper St. Lawrence Sub-region of the Great Lakes-St. Lawrence Forest Region (Rowe 1977). Forests in this sub-region include sugar maple, beech, red maple, yellow birch, white ash, basswood, largetooth aspen, and red and burr oaks. Most of the study area consists of open cultivated farm fields with occasional wood lots. Most of the old growth forest would have been cut down during the nineteenth century and the trees that can be found within the study area would be secondary or tertiary growth (Images 5, 14 and 20).

There are three large wet areas located within the study area. The first is located in the northwest corner (Image 14) while the second was located below the southeast corner of the quarry (Image 5). The third wet area was located in the southeast corner itself (Image 6). Drainage within the study area was provided by the larger Fournier Municipal Drain (Image 21), South Morrow Municipal Drain and York Municipal Drain, in addition to numerous smaller drainage ditches. The eastern arm of the study area was also notably more saturated due to the poor soil drainage (Image 17).

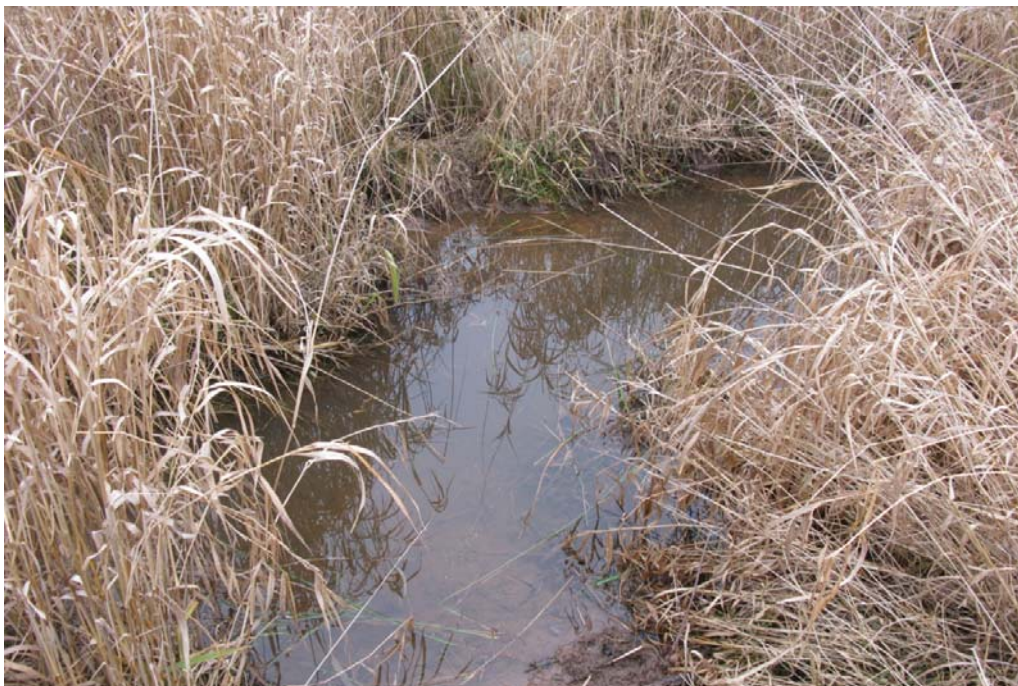
Image 6: Wet area located in southeast corner of study area, looking south east.

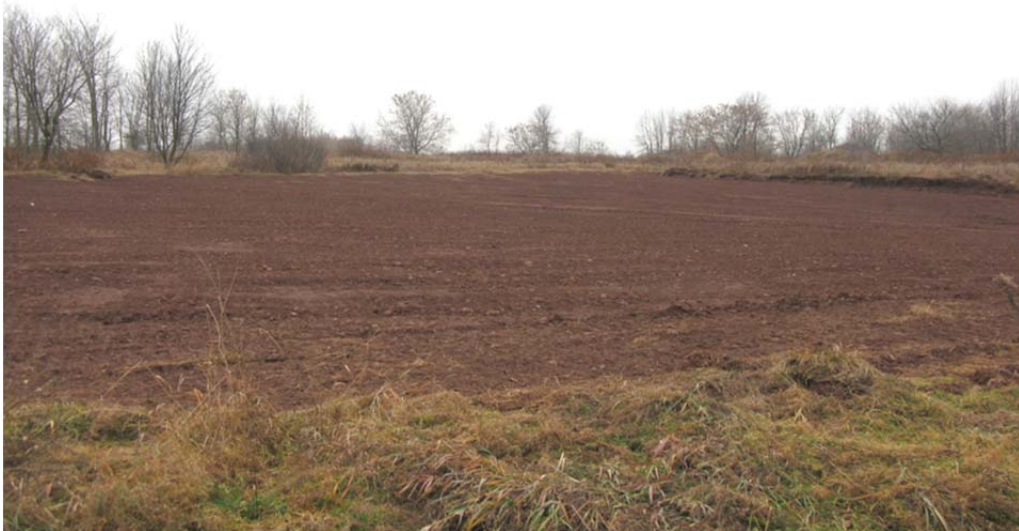
Image 11: Agricultural fields immediately west of existing quarry, facing west.

There were four soil types shown as located within the study area. The largest concentration of soil within the study area is Vars gravelly sand; it consists of slightly stony, gravelly loam soils with reddish gravel or shale parent material with good drainage (Image 11). The second soil type was Rubicon fine sand located in the northwest corner of the study area. It consists of light grey depressions and reddish brown hummocks of sandy soils with sorted sand parent material and had imperfect drainage. The other two soil types were only located in the eastern part of the study area. The first was Bearbrook clay, which consists of stone free dark grey clay soils with non-calcareous layered red and grey clay with poor drainage. The last soil type potentially found within the study area was Bainsville silt loam. It consists of stone free fine sandy loam soils with layered silt and fine sand with poor drainage (Wicklund 1962).

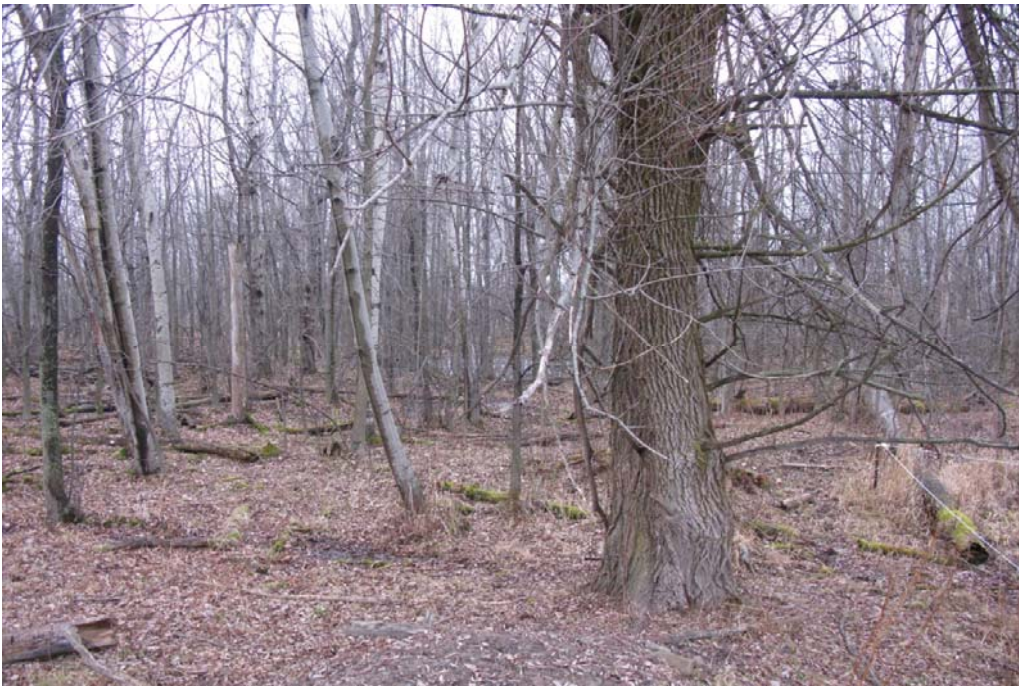
Image 14: Woodlot and wet area associated with South Morrow Municipal Drain, looking east.

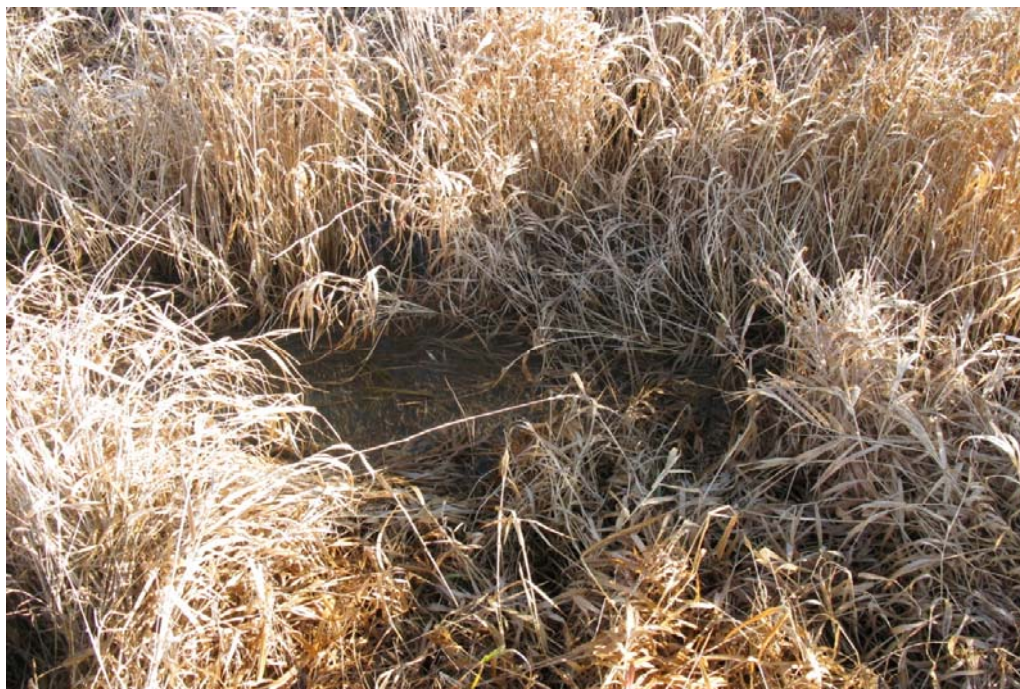
Image 17: Marsh grass and seasonal wet area east of Eadie Road, looking east.

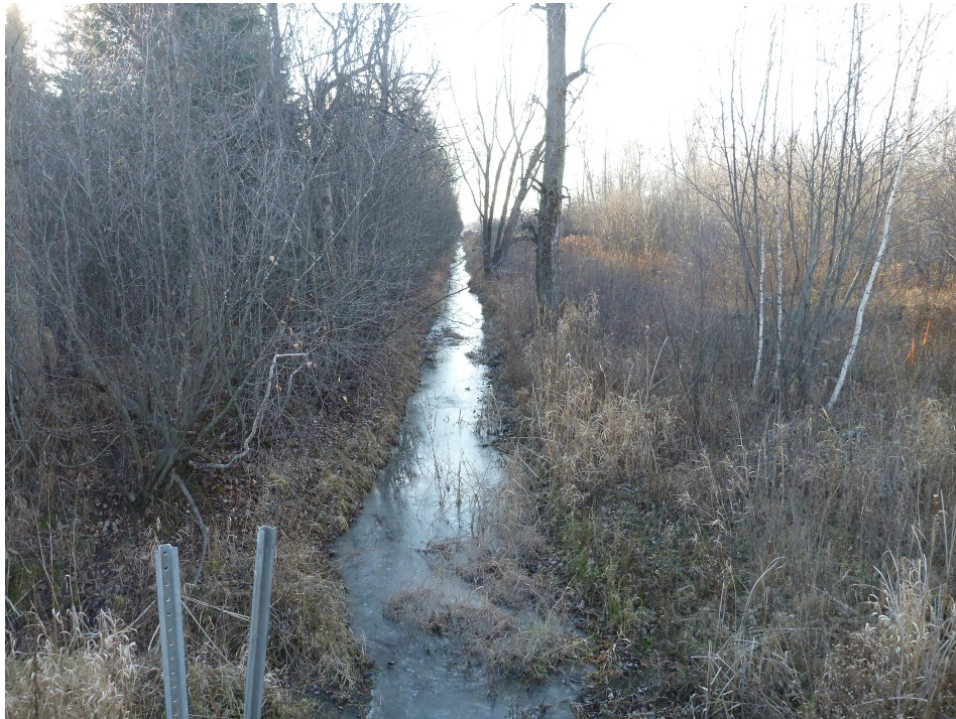
Image 5: Man-made drainage and culvert flowing through the study area, looking west.

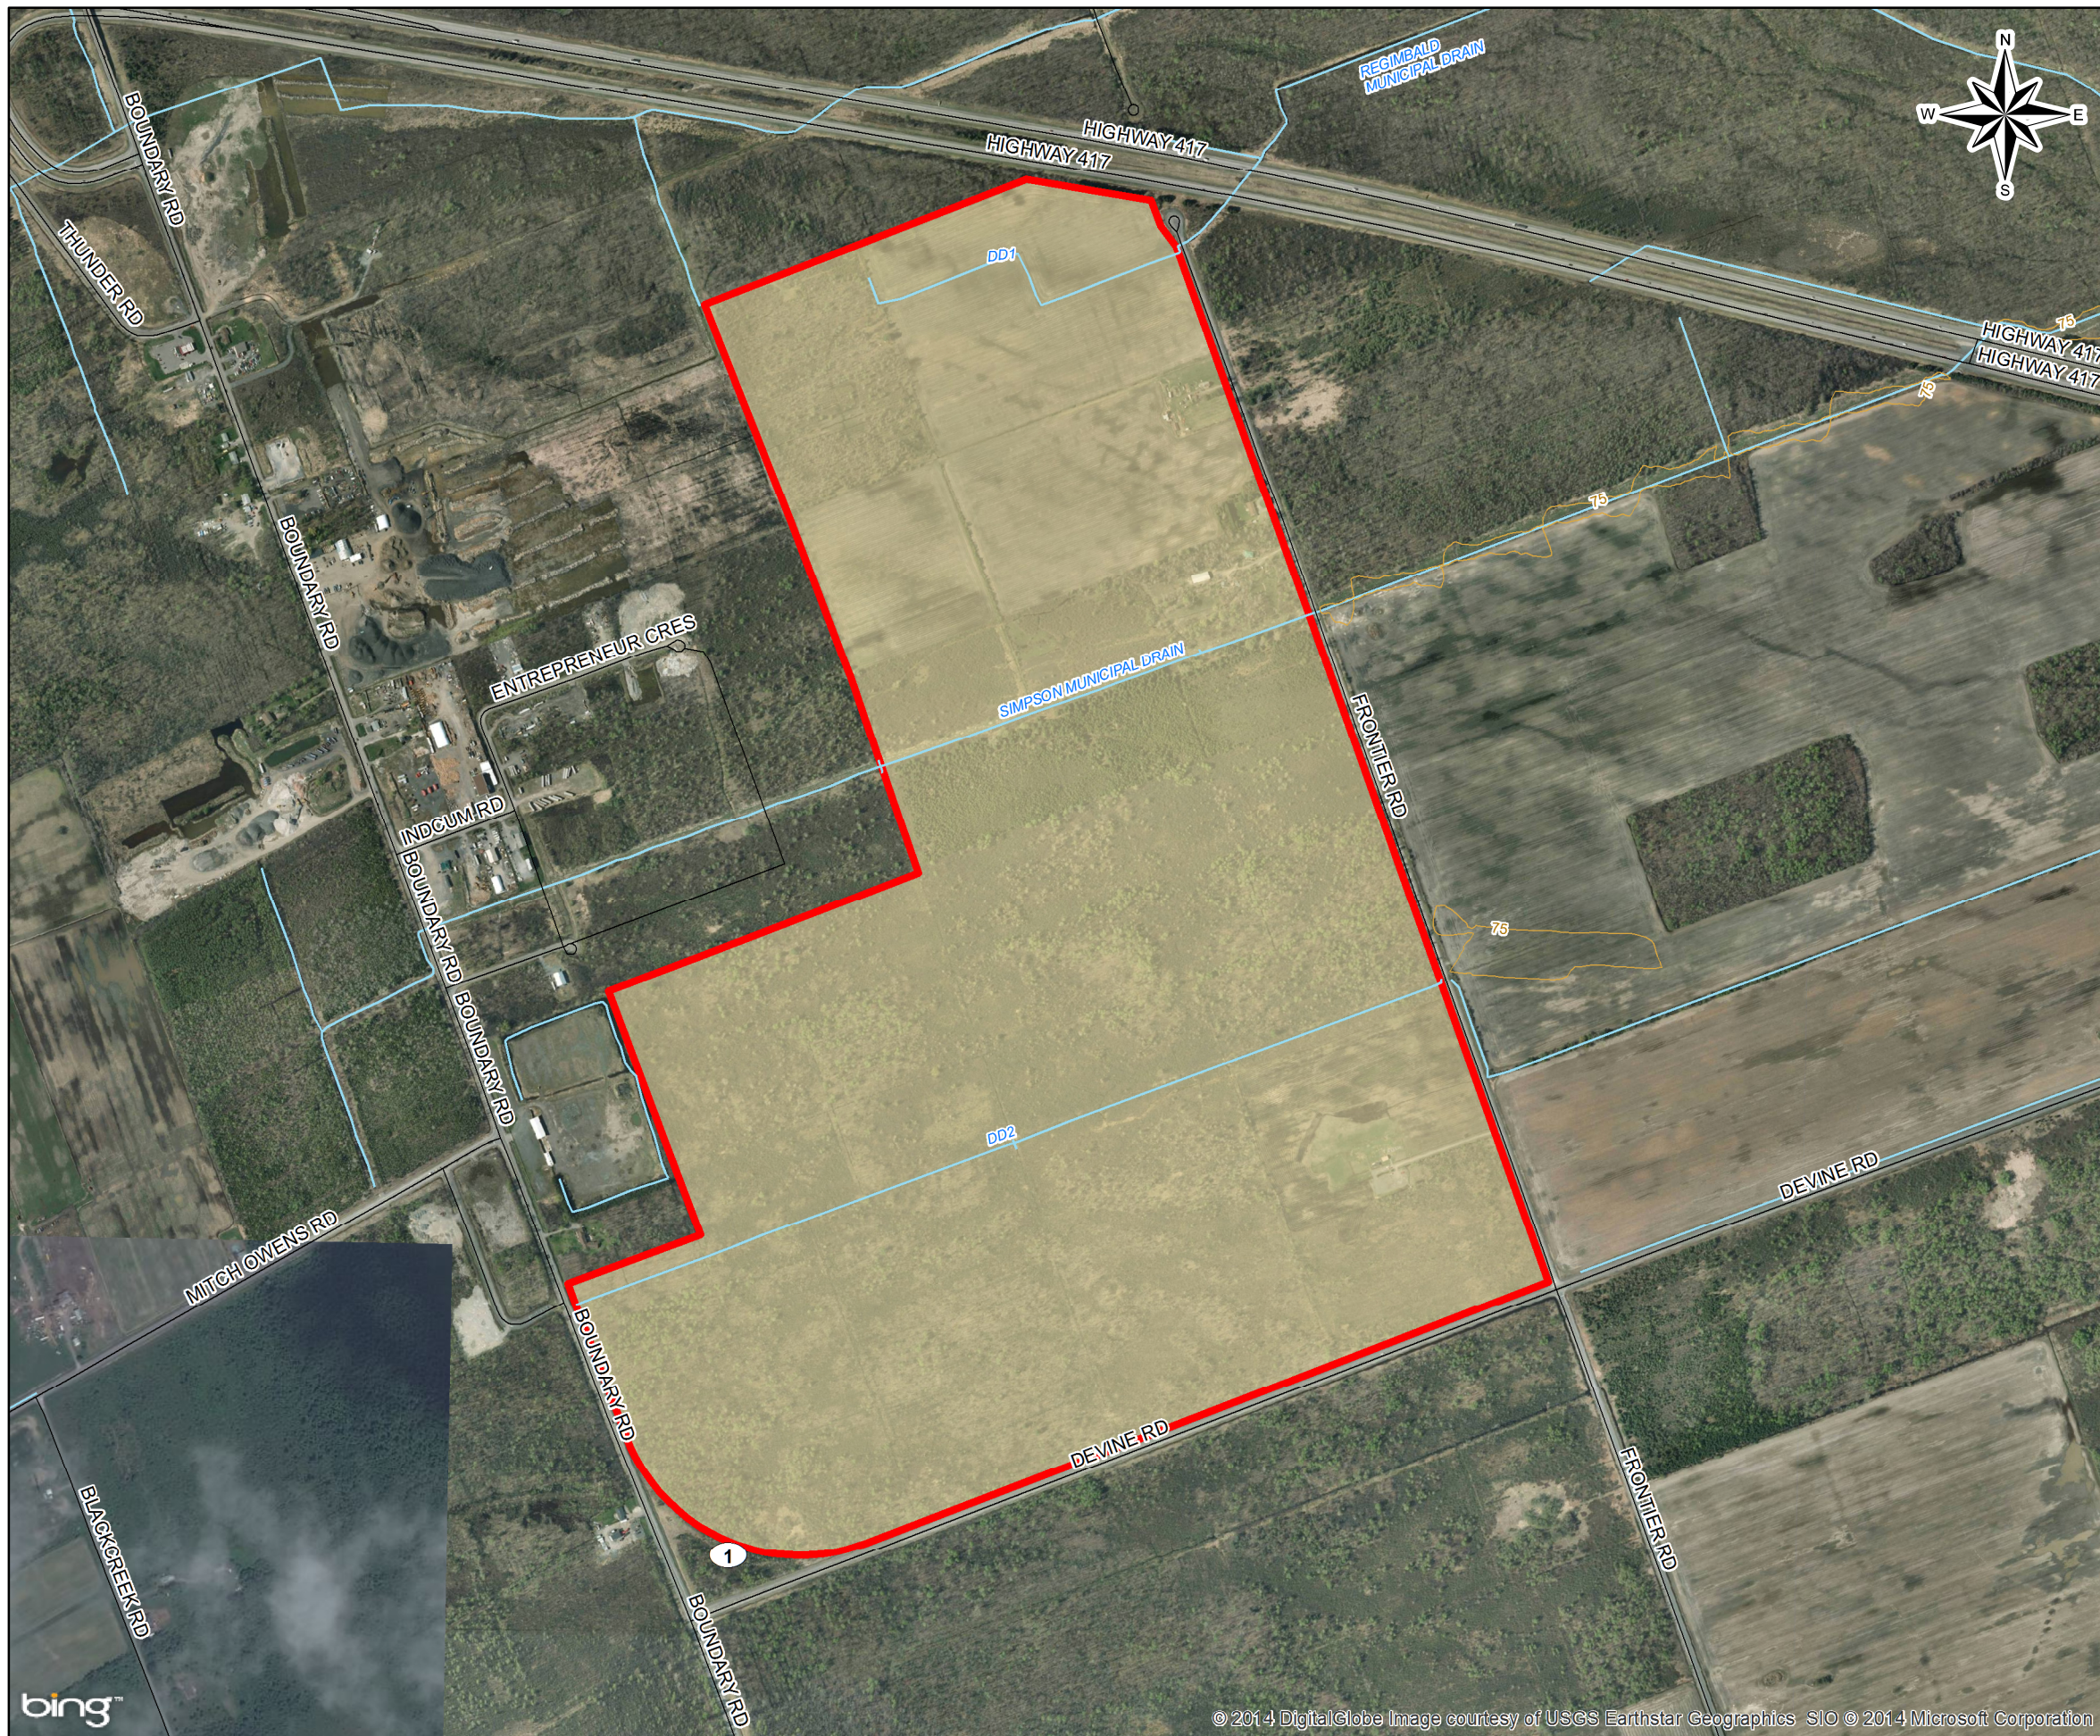
- LEGEND**
- ROAD
 - CONTOUR LINE, (5m)
 - SURFACE WATER FEATURE
 - PROPERTY BOUNDARY
 - LOW/NO ARCHAEOLOGICAL POTENTIAL
 - ① DESTROYED 19th/20th CENTURY FARMSTEAD

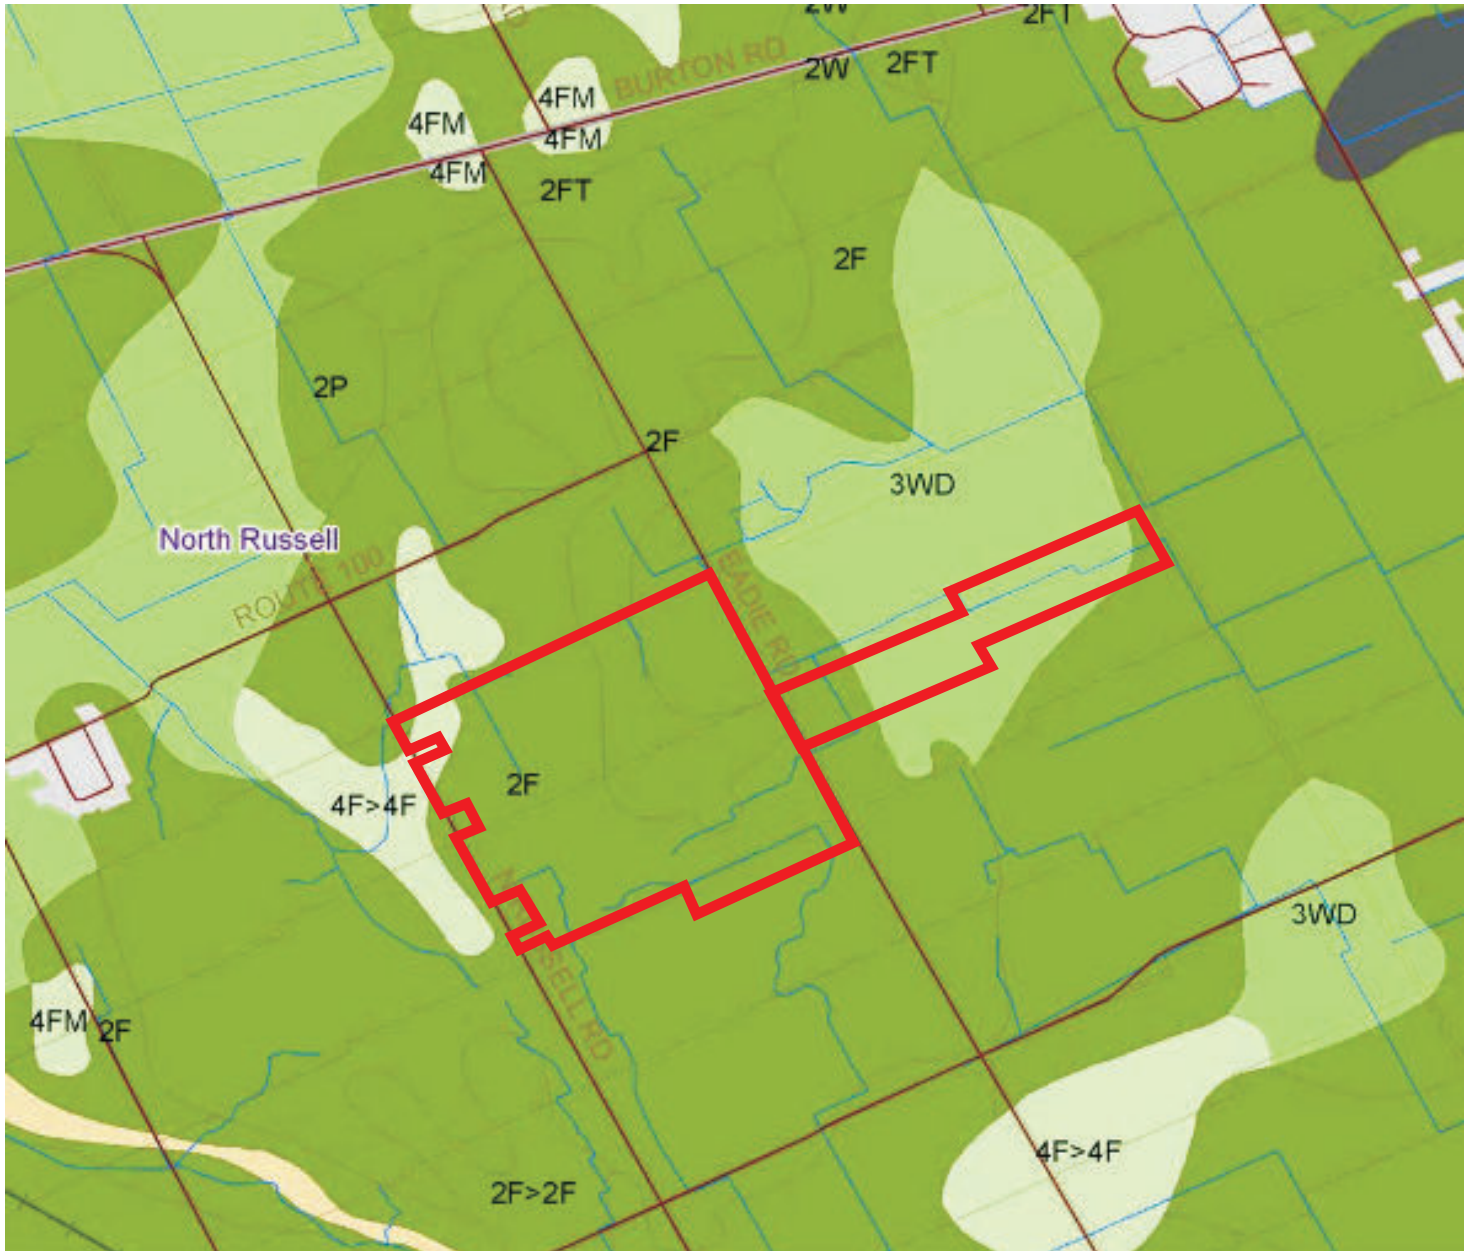
Figure 2.1-2 - CLI Map
 Part of Lots 18 and 19, Concessions 3 & 4
 Township of Russell

Canada Land Inventory Rating	
	1
	2
	3
	4
	5
	6
	7
	Organics
	N/A
	Water
